Purin Hall Renovation Feasibility Study

DFDM Project No. 17B1N
1-8-2018

**Purin Hall Renovation Feasibility Study
DFDM Project No. 17B1N
University of Wisconsin-Milwaukee**

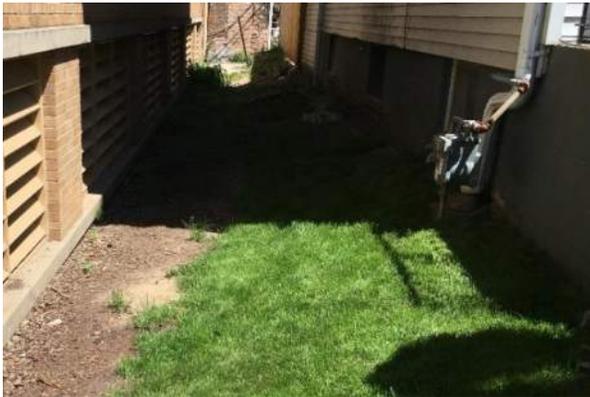
No footings or spread footings are visible. Foundation walls are 8" CMU block with some cracking observed on east elevation and water stains indicating that water has been present on the outside and water is entering at mortar joints. On east elevation, we observed that grade slopes to building. No perimeter drain tile or drainage system was installed around the building. It also appears that adjacent house gutter discharges out on grade (see Photo 1). We would recommend the drain tile to be added along the building on all four elevations especially along east elevations and adjacent property owner discharge his roof drain to storm outlet or away from your building.

Photo 1. Drain from adjacent building discharges out on grade

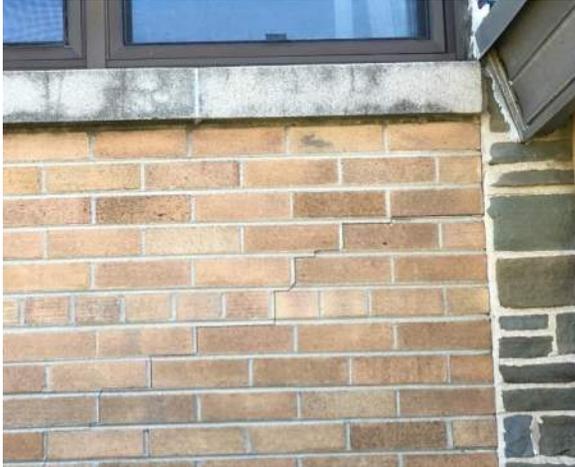
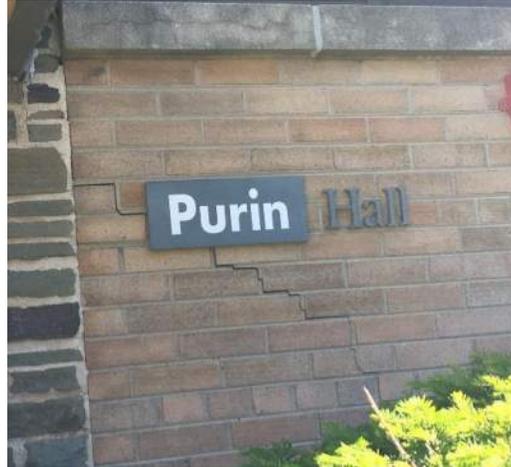
Some minor settlement and cracking was noticed on the foundation walls on the inside of parking garage and lower level. Visual observations of the exterior façade revealed some settlement on the south elevation – See stepped cracks at near south entrance and near roof in SE corner. See photos 2 through 5. These cracks need to be tuck pointed sometime in the near future (two years).

Photos 2-3. Stepped cracks in the exterior brick façade

Visual observations of the exterior façade revealed some settlement on south elevation – see photos 2 through 5 stepped cracks at near south entrance and near roof in SE corner.

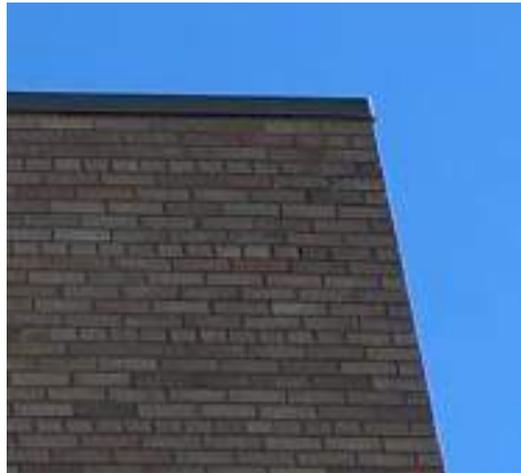
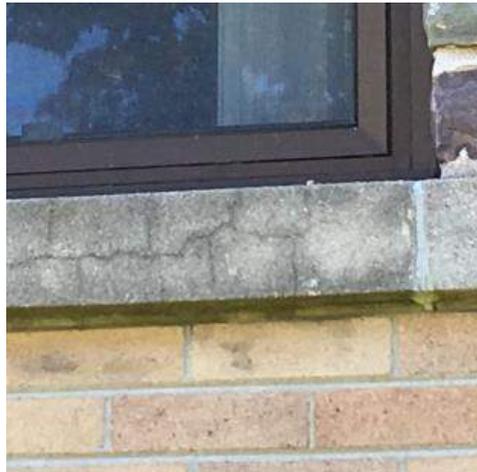
Photos 4-5. Stepped cracks in the exterior brick

Exterior continuous limestone bands above and below windows are showing some hairline cracking. The hairline cracking is due to water being trapped behind limestone and freeze thaw damage has started to deteriorate & crack limestone. The cracked limestone is worse at windows especially below windows, see photo 5.

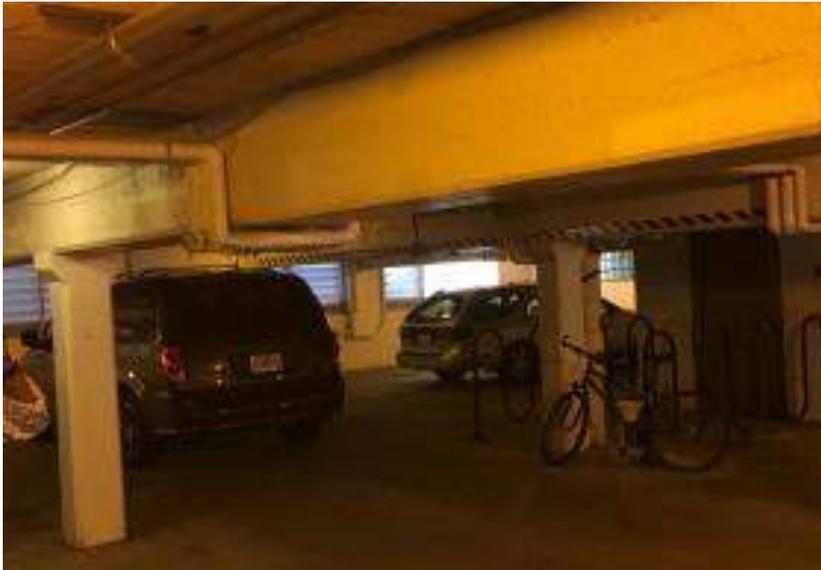
The parking garage has very low overhead clearance of 6'-0". We would recommend that an option to lower the slab on grade by 1 ft. be explored, so the minimum clearance is 7'-0" under beams. This would also allow room for putting in an insulated ceiling so the pipes do not freeze during winter, which is an on-going problem presently, see photo 6. Ventilation needs to be added to parking garage. Presently the louvers are covered with plastic to keep out the cold, see photo 7. This is a code issue and needs to be addressed.

Photo 6. Low ceiling clearance in the garage. Exposed pipes freeze during winter

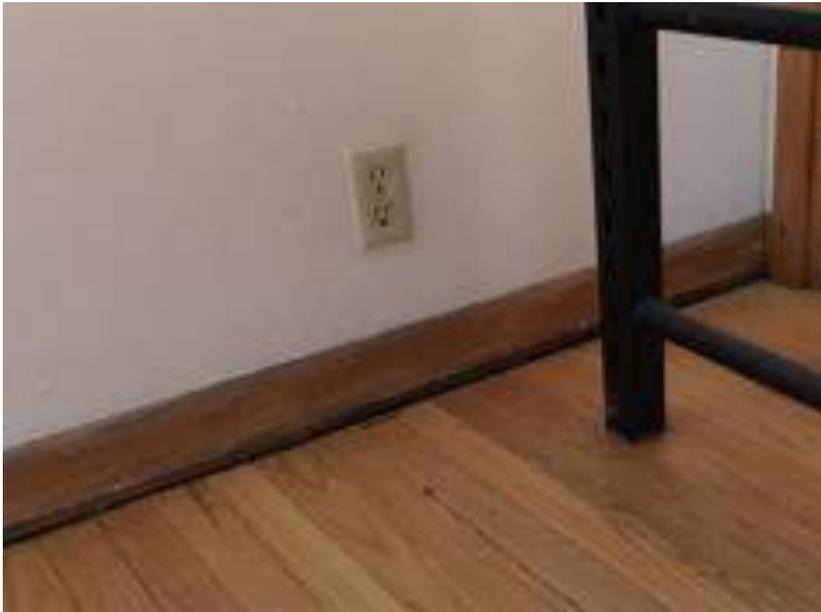
We did observe some settlement on 1st floor, 2nd floor and 3rd floor (1/4" to 1/2"). The settlement is minor for this age of building and can be repaired. See photos 8 and 9.

Photo 8. Settlement on the 1st floor

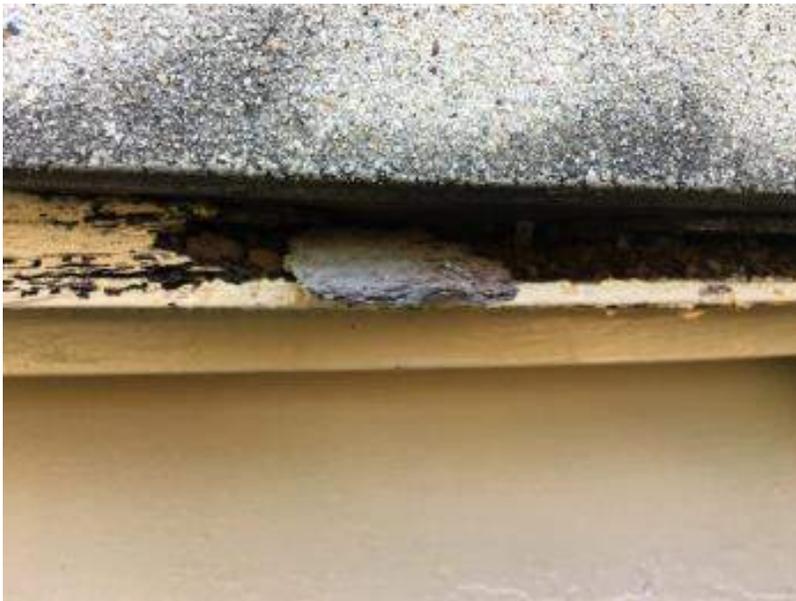
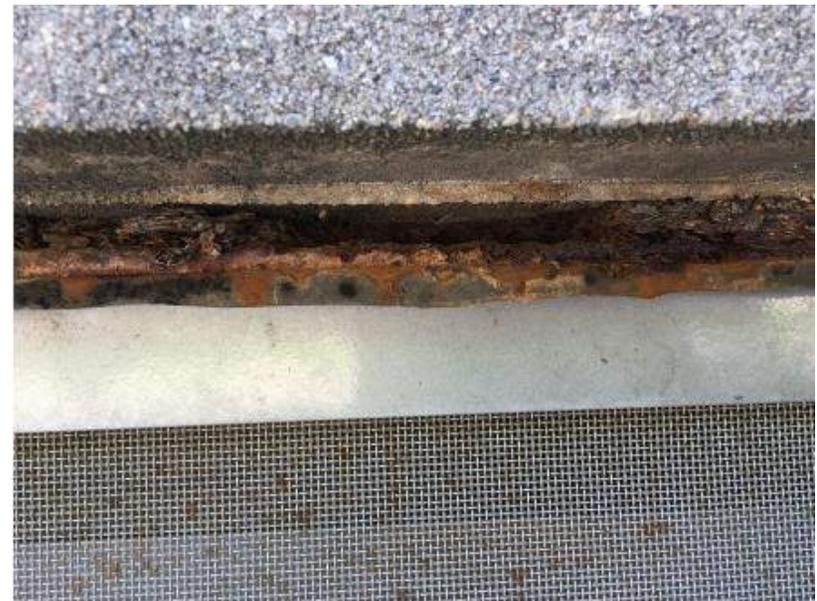
The most significant structural concern was with the steel lintels. The existing building façade was not constructed with weep holes so moisture permeating the brick veneer has no practical means of escaping the cavity between block and brick face. Water is running down back face of brick and exiting out at the steel lintels. The steel lintels are badly corroded and have rust jacked (rotated), see photos 10-11. Four steel lintels have failed and are no longer supporting the brick & limestone bands over window openings. See photo 9 showing failed steel lintel. Some racking of window units is noticeable making windows hard to operate along with fracturing of ceramic window sills. In garage, popping of glass block is evident from steel lintel failure.

Photos 10,11. Examples of rusted and rotated steel angle lintels

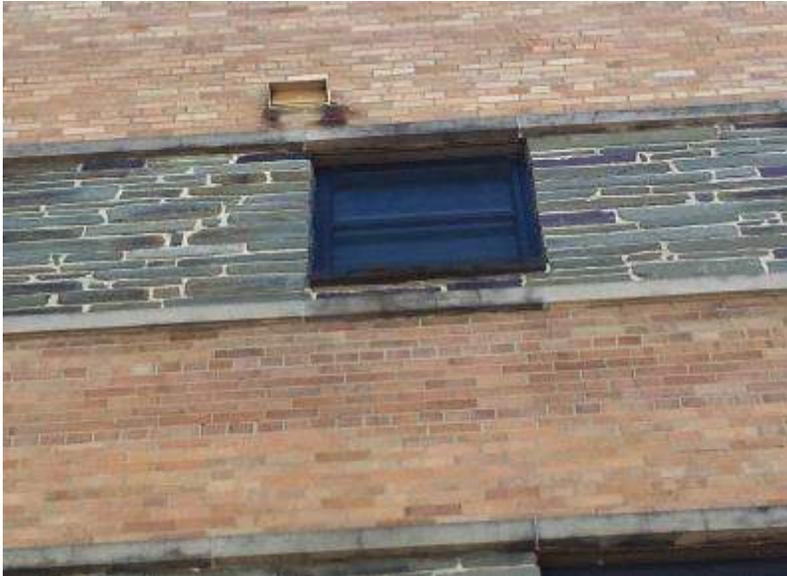
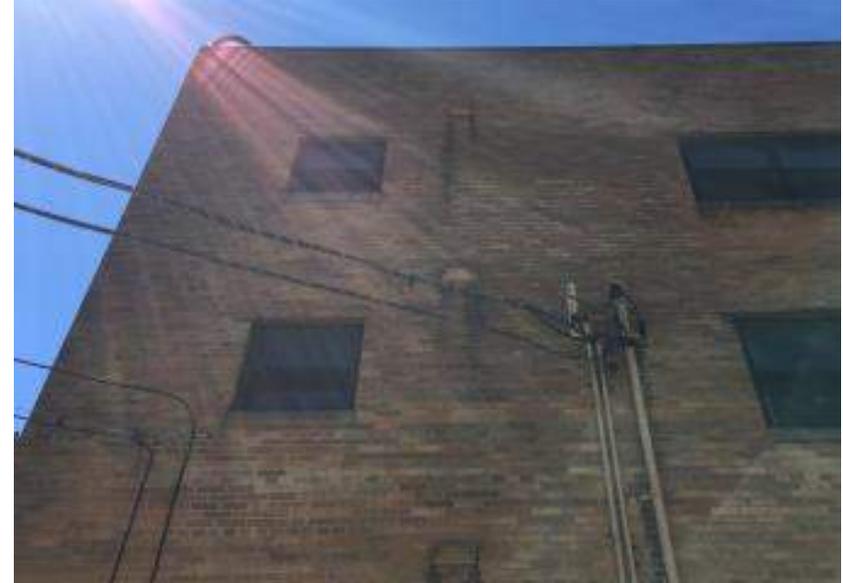
We also observed that bricks were turned 90 degrees every 6 courses. We therefore believe that both limestone bands and turned brick are toothed into 8" masonry back up. This would eliminate the need for steel brick ties. This needs to be verified in the field by removing a 48" x 32" section of brick in two locations to verify if brick and limestone are toothed in and to verify condition of steel angles, see photos 12-13.

Photos 12-13. Examples of brick rotated 90 degrees at the exterior façade

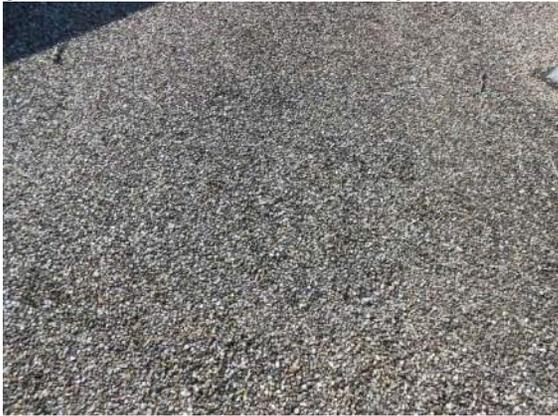
No blisters, soft spots or splits were noted in the field area of the roof, see photo 14. The amount of gravel and embedment of the gravel in the flood coat was adequate. The field membrane could continue to perform for approximately another 5 years with routine monitoring and maintenance.

Photo 14. No blisters or soft spots in the field area

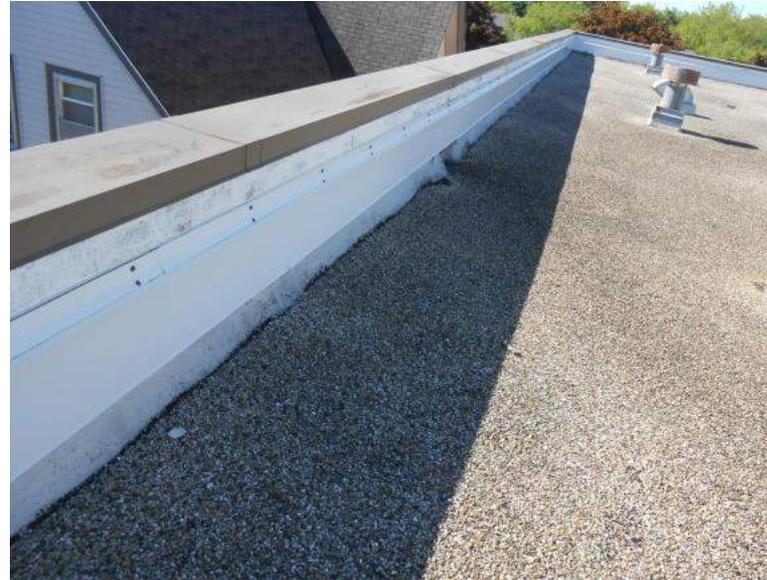
Photo 18. Wall steel coping

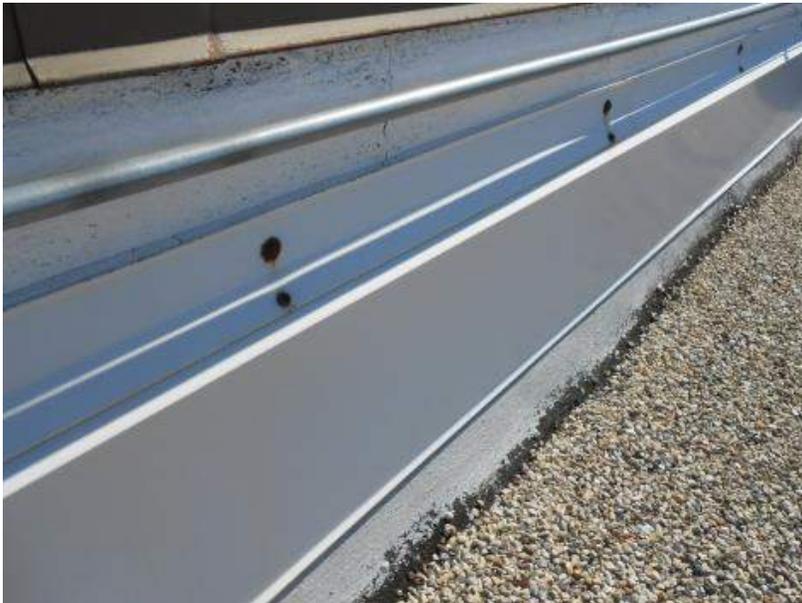
The unusually-tall metal counter flashing and surface-mounted retained appeared sound and covered a large portion of this wall, see photo 19. The condition of the block wall behind the metal is not known. In the short-term, the line of sealant should be inspected routinely and replenished as needed, see photo 20. The defective mortar joints and spalling surface of the block wall should be restored in the short-term to prevent water from penetrating the wall and / or getting behind the flashing components.

Photo 19. Example of metal counter flashing

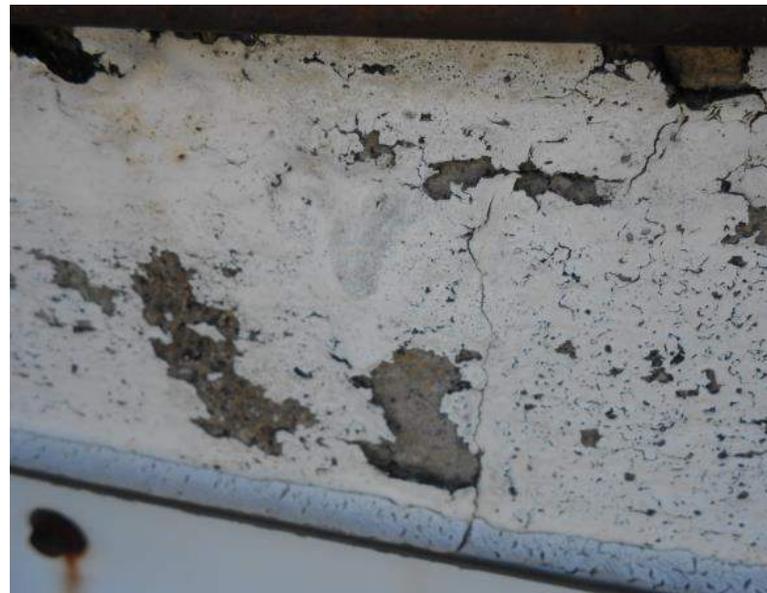
Photo 20. Example of line sealant and spalling surface

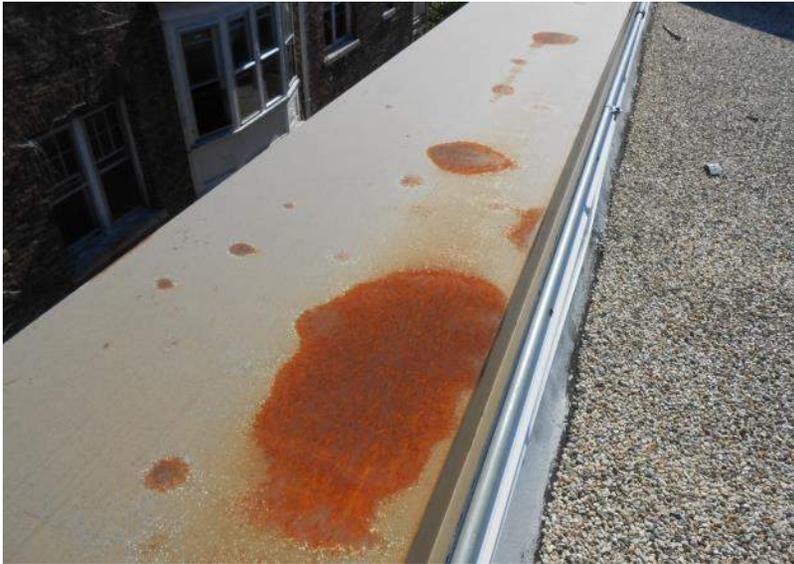
The metal copings anchored to wood blocking likely replaced deteriorated concrete or tile copings atop the parapet walls, see photos 21-22. The metal was fairly secure despite not having full length cleats. A fair amount of corrosion was present. A basic refinishing of the copings could help them perform until the roof system is eventually replaced.

Photo 21. Example of corrosion on metal coping

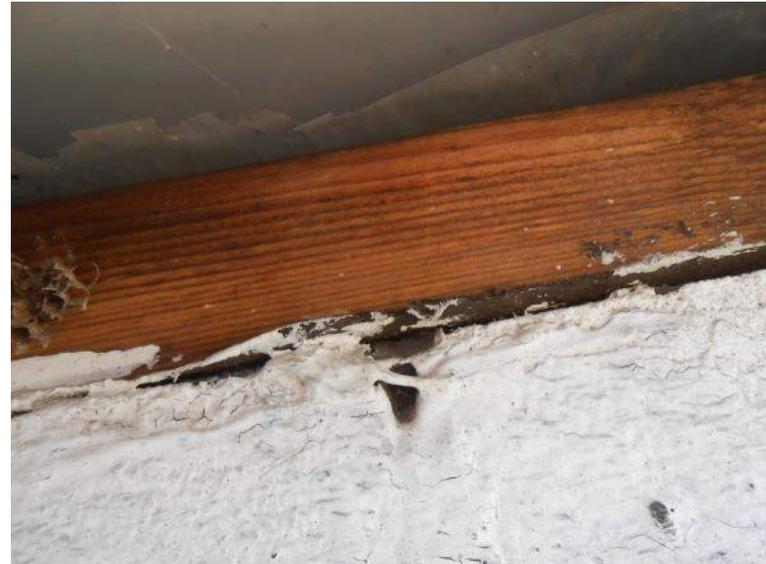
Photo 22. Example of wood blocking under metal coping

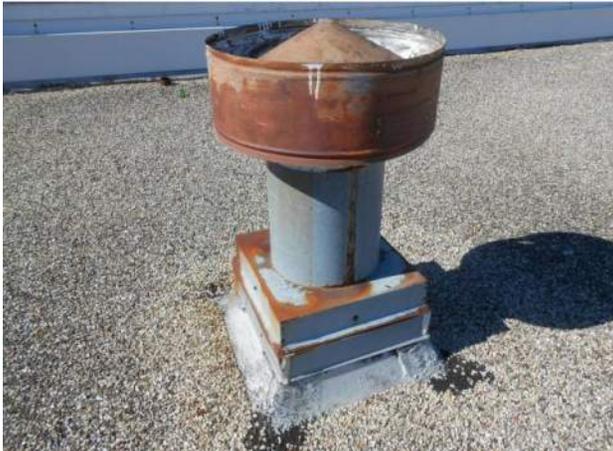
The exposed base flashings surrounding the various vent curbs were mildly deteriorated, see photo 23, and would need restoration similar to the parapet wall flashings to perform in the mid-term. In the absence of perforations from heavy corrosion, the various vents will likely continue to perform until the main roof gets replaced. The flashings surrounding the center chimney appeared sound with the exception of the flashing at the base of the louvered vent panel. The defect needs repair in the short-term. The flashing components around the base of the chimney in the southwest corner of the roof appeared sound. Defective mortar joints in the chimney need to be corrected in the short-term.

Photo 23. Example of flashing surrounding the curb
