Purin Hall Renovation Feasibility Study

DFDM Project No. 17B1N
1-8-2018

**Purin Hall Renovation Feasibility Study
DFDM Project No. 17B1N
University of Wisconsin-Milwaukee**

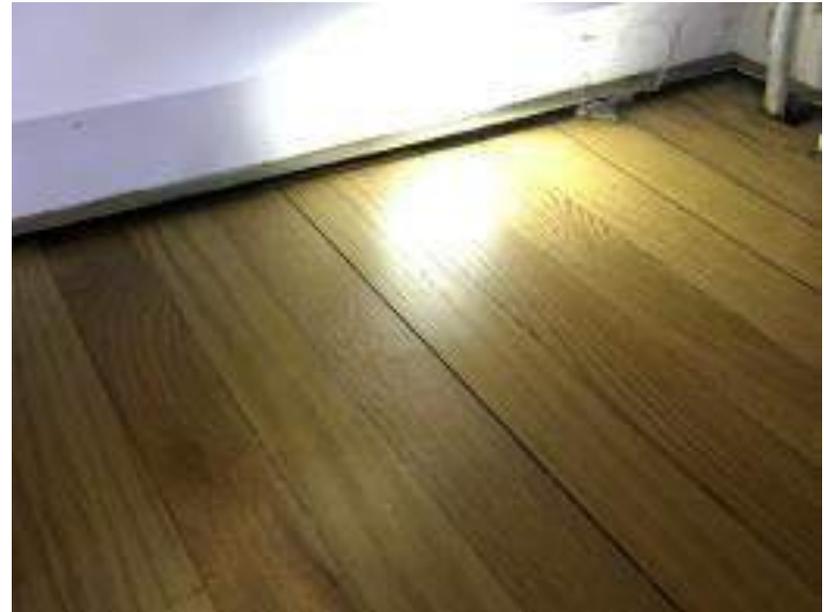
We did observe some settlement on 1st floor, 2nd floor and 3rd floor (1/4" to 1/2"). The settlement is minor for this age of building and can be repaired. See photos 8 and 9.

Photo 9. Settlement at west elevation on 3rd floor

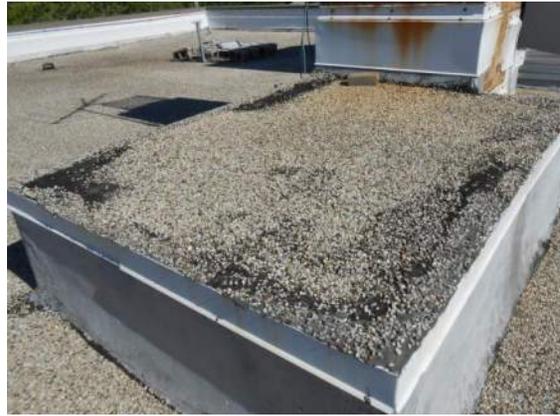
Photo 15. Example of bare spots and patching

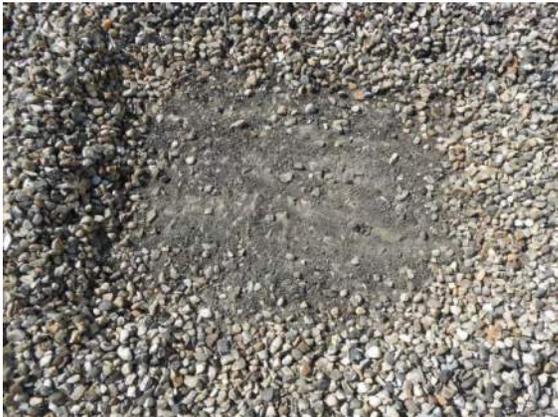
Photo 16. Example of bare spots and patching

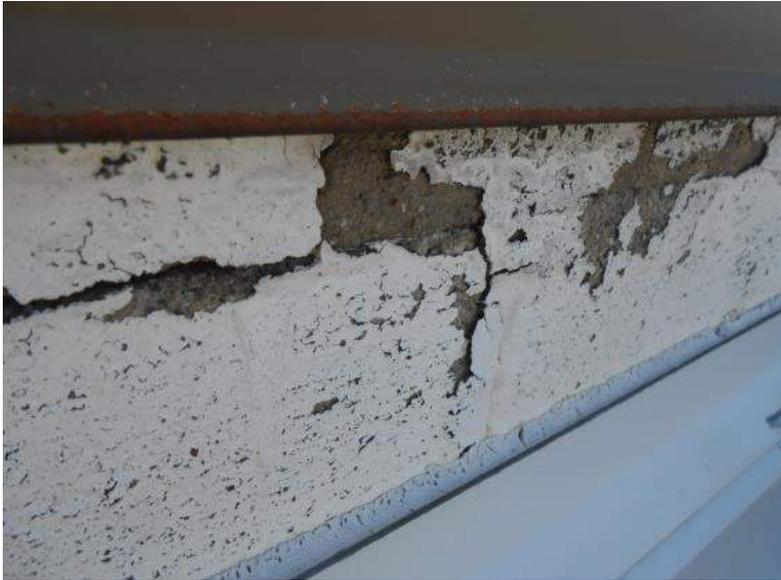
The parapet wall inner surfaces had an aluminum coated composition base flashing, tall pre-finished steel counter flashing and a narrow band of exposed concrete block, see photo 17.

Photo 17. Inner parapet surface construction

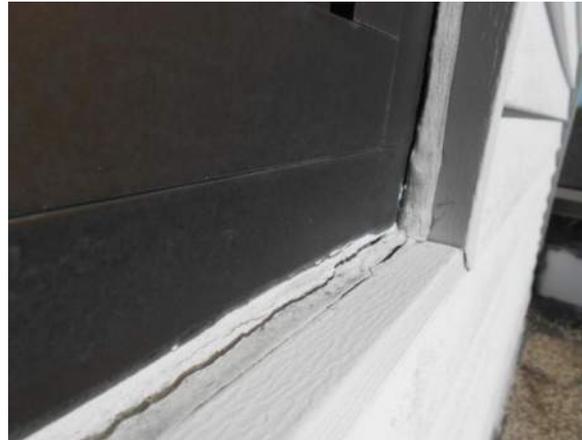
The base flashing around the penthouse was weathered similarly to the balance of the roof flashings. Some of the west-side vinyl siding panels were loose and needed to be re-anchored. The window-to-siding trim seal needed to be replenished to prevent water from getting behind the siding panels, see photo 24.

Photo 24. Example of window-to-siding trim seal

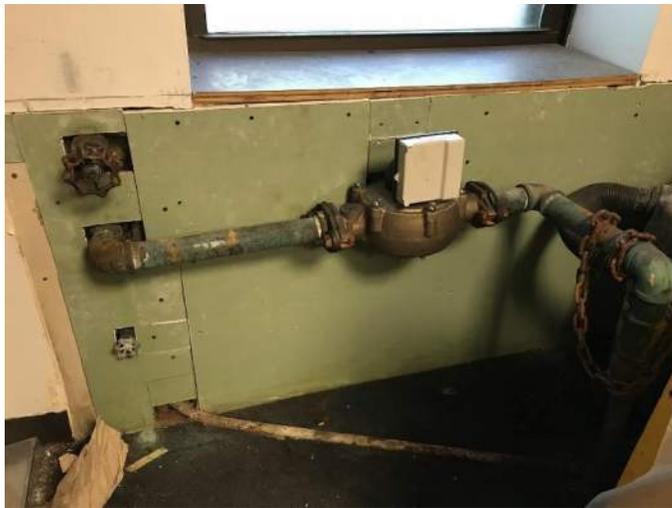
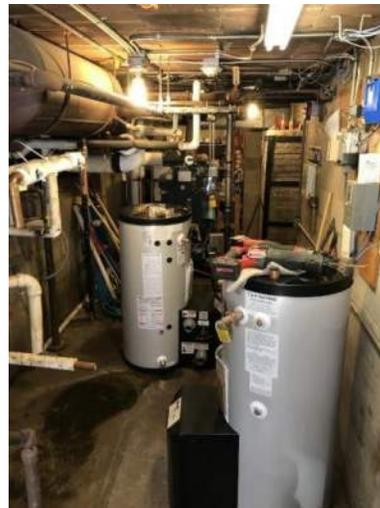
- Building is served by a domestic only 2" water service that enters the basement level in a storage room.
- Water piping is a combination of galvanized steel and copper. The copper is in good working condition but the galvanized steel piping is nearing the end of expected life and has had to have repairs in recent years.
- Two new high efficiency gas-fired sealed combustion water heaters are being installed this summer. Each heater has a 55 gallon storage capacity and a separate storage tank is being installed. The hot water is circulated through the building at 120F.
- There is not a water softener.

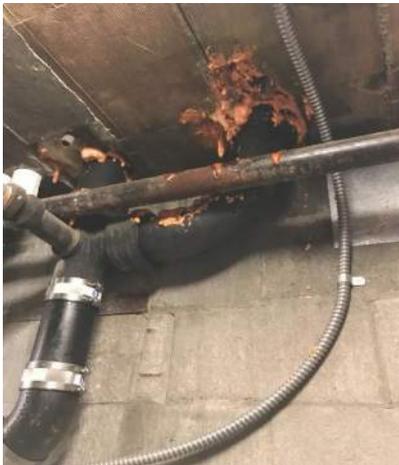
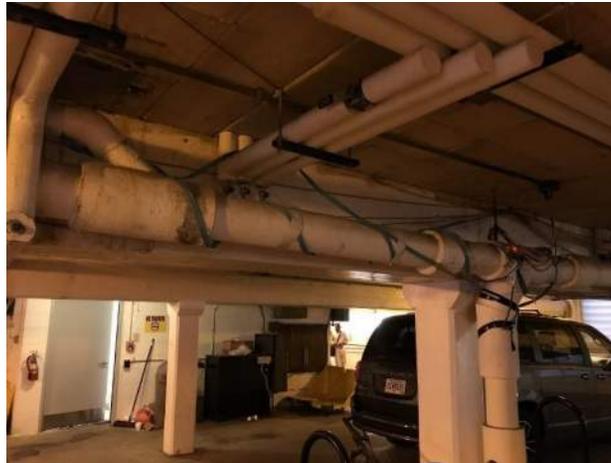
- Sanitary piping is black steel and in fair working order.
- There is a drain in the parking garage but no oil separator.
- Piping routed in the parking garage is subject to freezing and some heat trace has been added to some of the pipes.
- There are no existing drawings indicating size or extent of underfloor piping. If reuse of this piping is explored, additional scoping is recommended to confirm size, configuration and condition. Building does not have any sewage ejector pumps and is served by gravity. No known issues with sanitary blockages in system and piping is original to the building.
- D2030Storm
- Roof drainage is a combination of piped roof drains, roof scuppers, and downspouts.

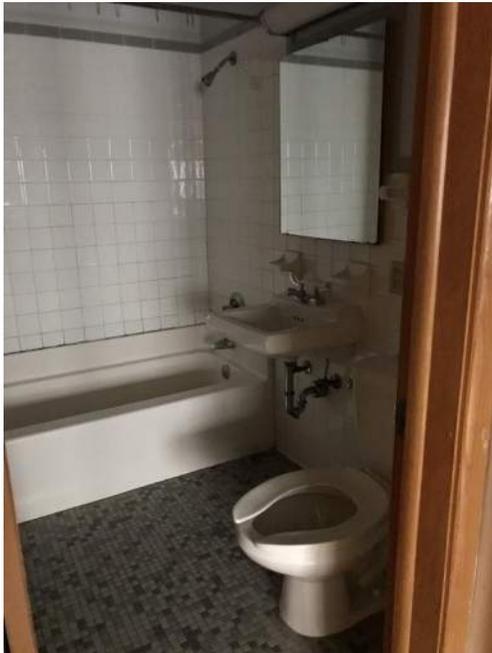
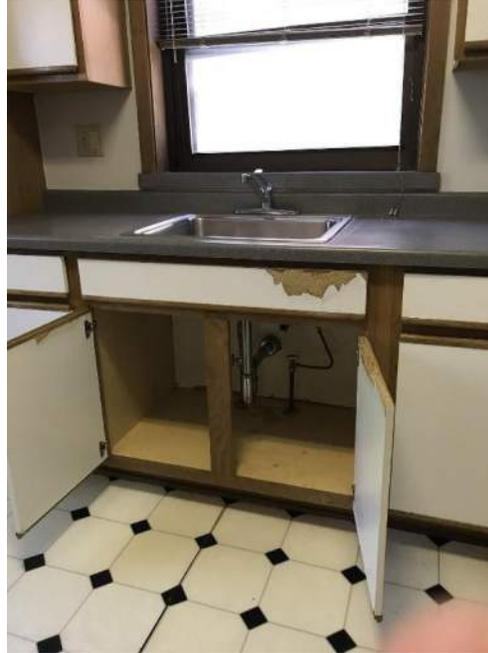
- Plumbing fixtures are original to the building and do not meet current water conservation requirements.
- Kitchen sinks do not have garbage disposals and are located at exterior walls and are subject to freezing in winter.

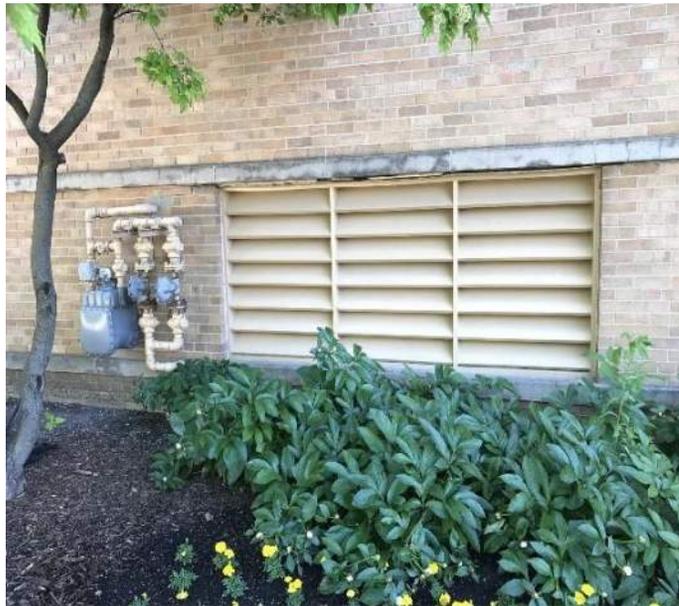
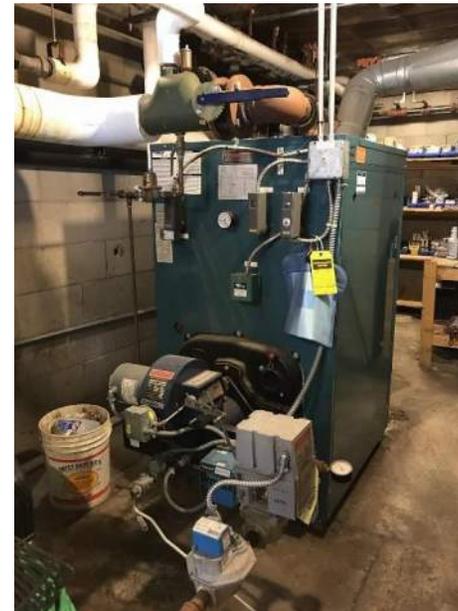
- Heating equipment is gas-fired. Gas meter is located outside near the parking garage entrance on the south side of the building.
- Building is served by a single steam boiler that was installed in 2006. The boiler is in fair condition but not as efficient as newer sealed combustion condensing style boilers.
- There are no steam traps installed at terminal equipment, so system has frequent air issues that have to be addressed as an ongoing maintenance issue

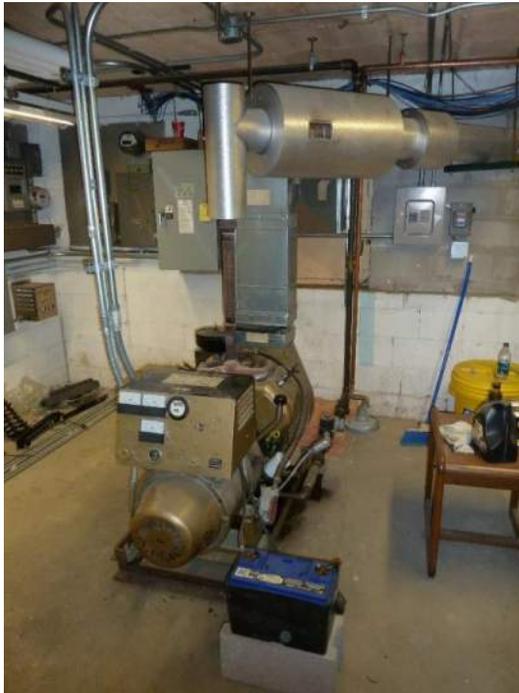
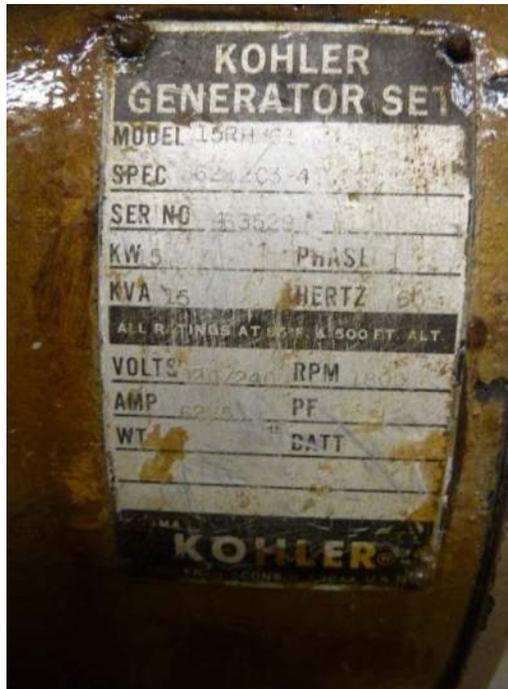
- D5010 Building Power Generation D5010.1 Generator
- The emergency generator is 15KW, 120/240V, single phase, natural gas, and located in the lower level electrical room.
 - The generator is nearing the end of its useful life.
 -

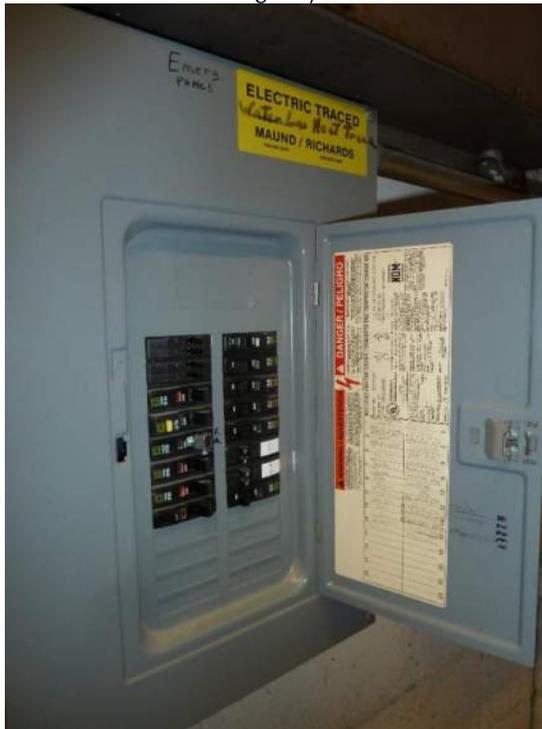
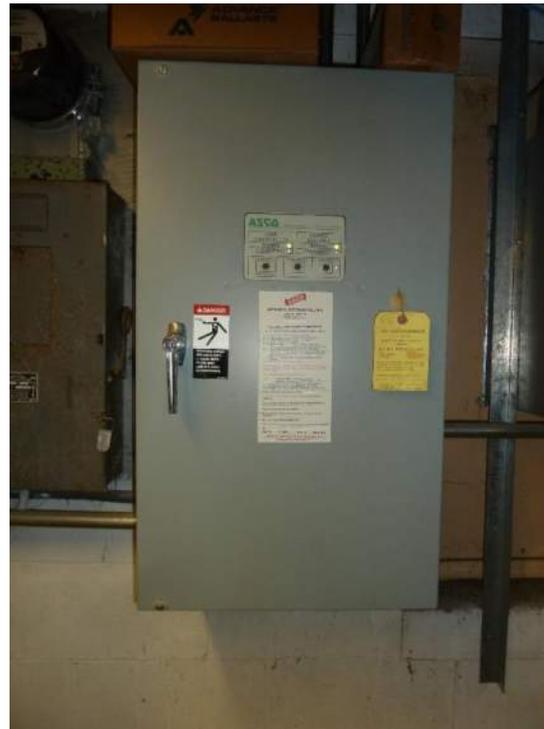
D5010.2 Emergency Power Distribution

- The generator feeds an automatic transfer switch and 24 circuit load center which serves all emergency loads in the building.
- The ATS and load center are not original and are in good condition.
- As constructed the emergency load separation would not meet current code at the existing load center. NEC 700 emergency loads are fed from the same transfer switch and panel as NEC 702 optional loads (boilers, sump pump, etc.).
- As constructed the selective coordination arrangement would not meet current code at the existing overcurrent devices serving emergency loads.

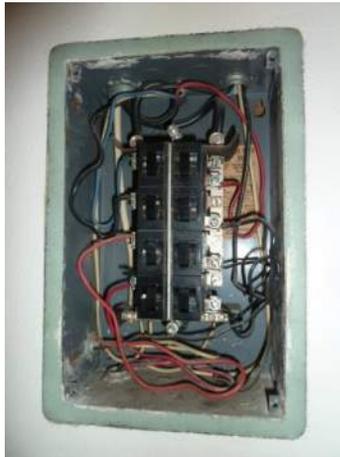
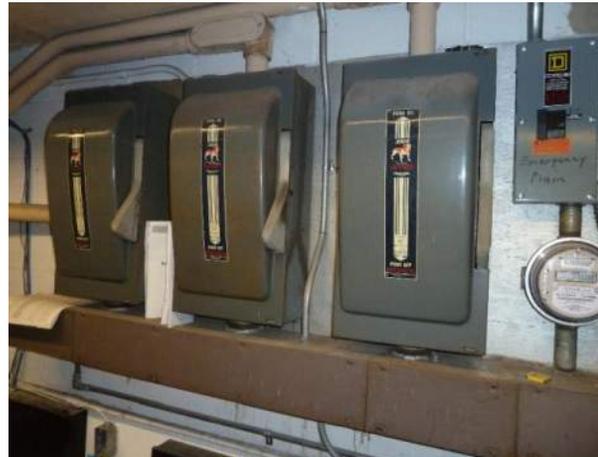
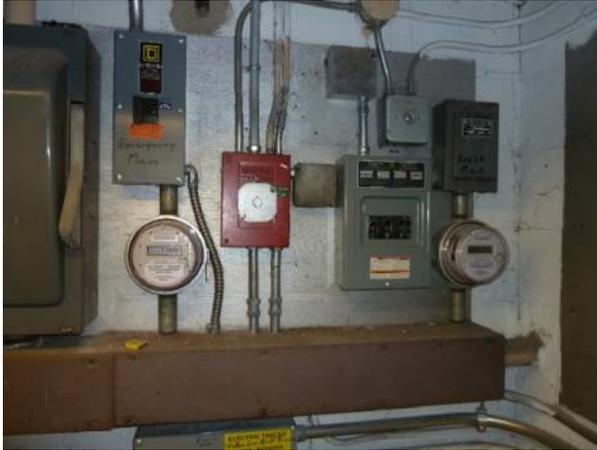
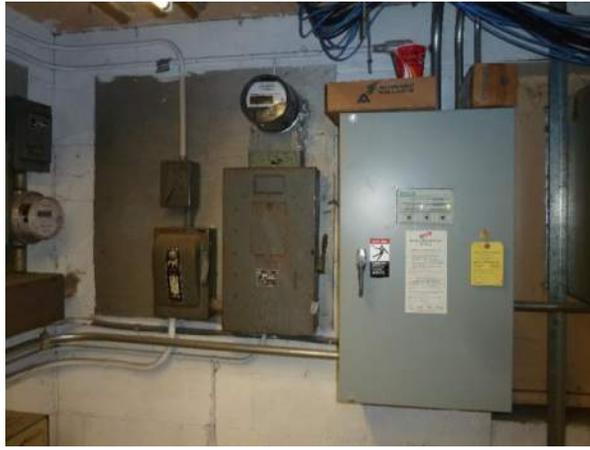
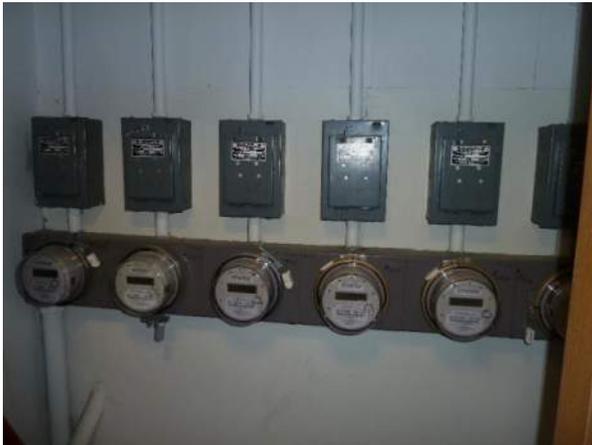
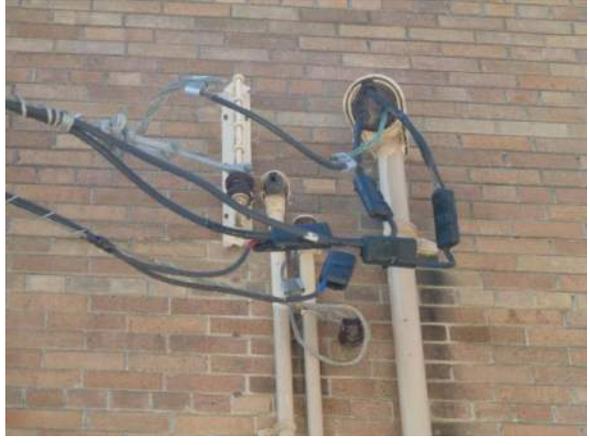
D5020 Electrical Service and Distribution

- Two overhead services enter the building in the lower level electrical room. One service is 120/240V, single phase, 2 pole, 3 wire and feeds three 200A service disconnect switches. The other service is 120/240V, single phase, 2 pole, 3 wire and feeds the elevator.
- Metering is separated for each resident unit, the elevator, the emergency feeder, and “house” power.
- Each resident unit has a dedicated load center in a closet. All load centers on one floor are fed from one of the 200A service disconnects.
- All normal electrical distribution equipment is original and at the end of its useful life. Spare parts are not available for most equipment.
- Equipment grounding conductors are not present in branch circuits or feeders. This could result in poor grounding at panels and devices.
- Conductors in
- Load centers in resident units do not have required working clearance in front of them.

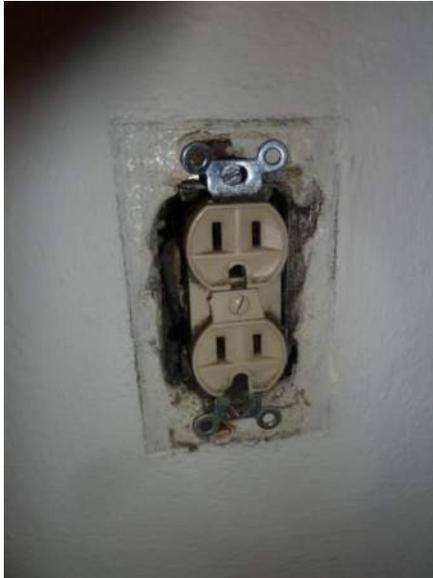
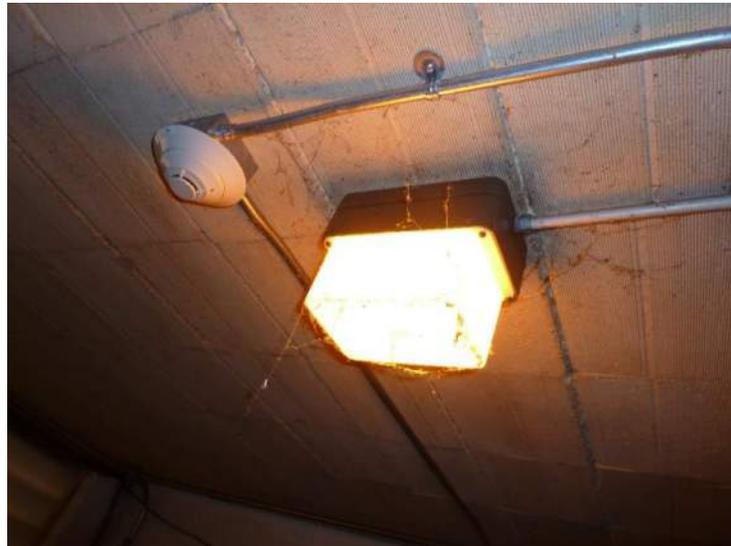
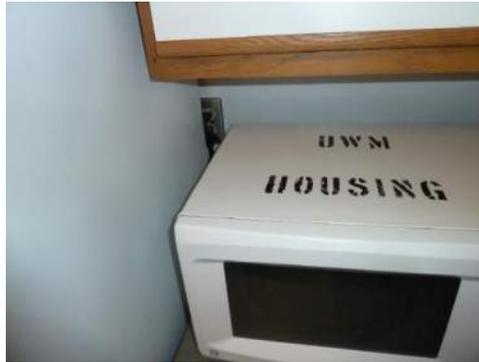
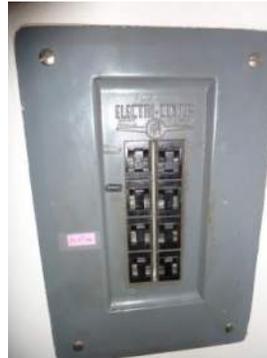
D5030 General Electrical Power

- The number of branch circuits in the resident units does not meet current code. This includes the microwave and refrigerator circuited to the same breaker or plugged into the same receptacle and causes circuit overloads.
- Receptacle spacing in resident units does not meet current code.
- Some 15A circuits have 20A receptacles circuited to them and do not meet current code.
- Some two pole breakers in load centers do not have code required breaker ties.
- Branch circuit breakers in resident units do not have arc fault protection, which does not meet current code.
- Receptacles in the resident units are not tamper-resistant, which does not meet current code.
- Elevator branch circuits and overcurrent protection do not meet current code.

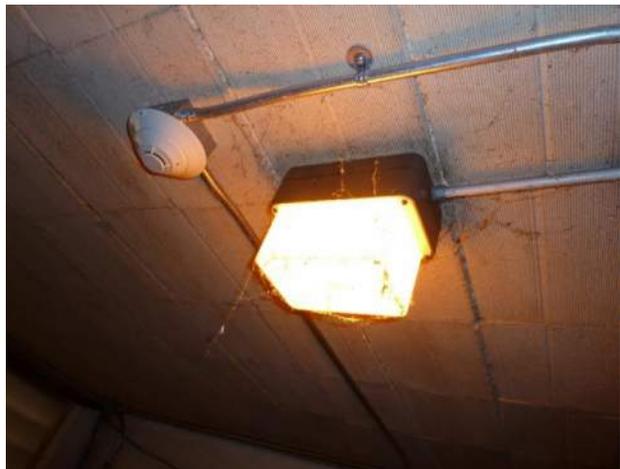
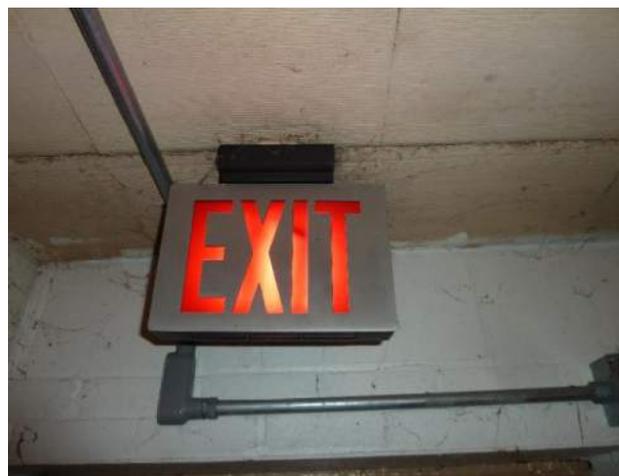
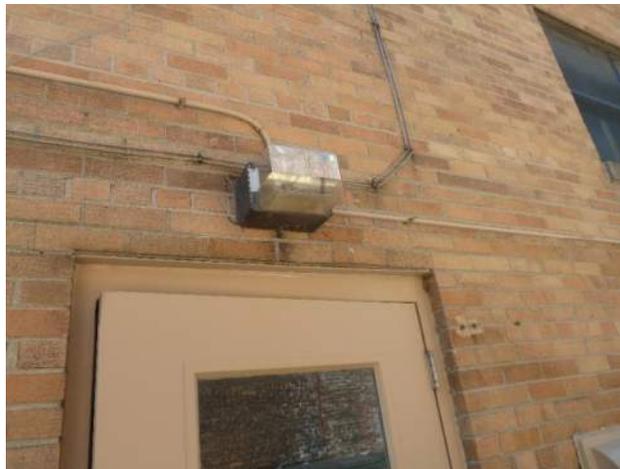
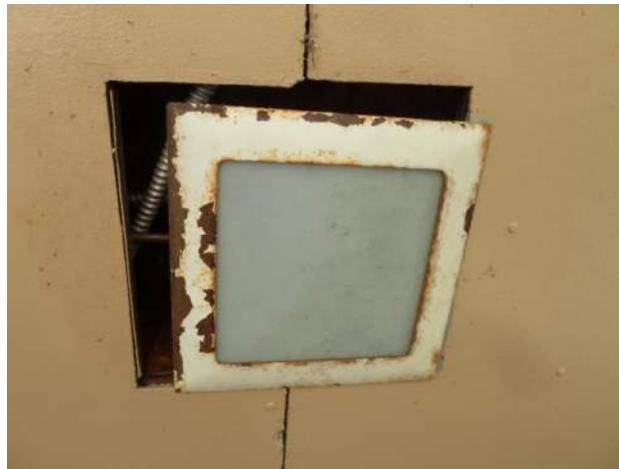
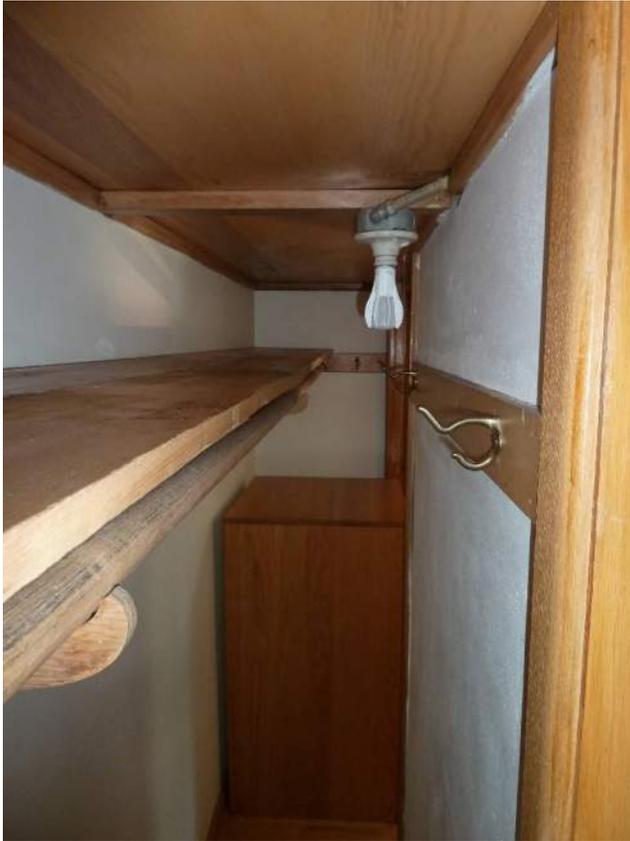
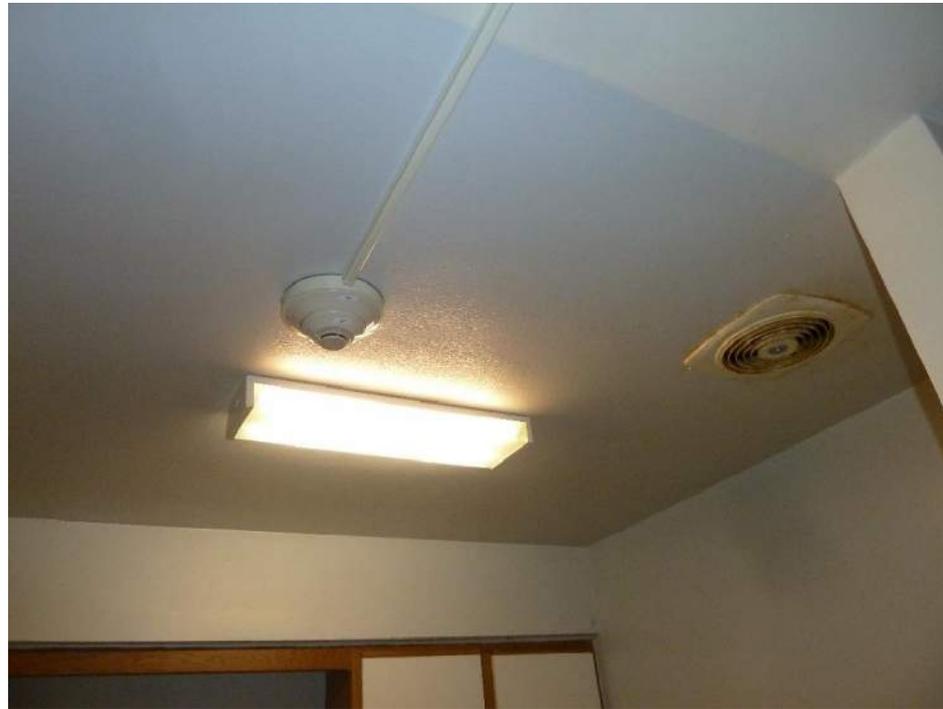
D5040 Lighting

- Exit signs are incandescent type.
- Most light fixtures are original or in poor condition and are at the end of their useful lives.
- Footcandle levels for normal power egress path illumination in stairs and corridors do not appear to meet current code.

- Light fixtures and a timer switch are installed in one of the third floor bathrooms. The light fixtures and switch do not appear to be listed for this application.

- Lighting watts/square foot levels do not appear to meet current energy code.
- Light levels throughout the building appear to be below IES recommended minimum levels.

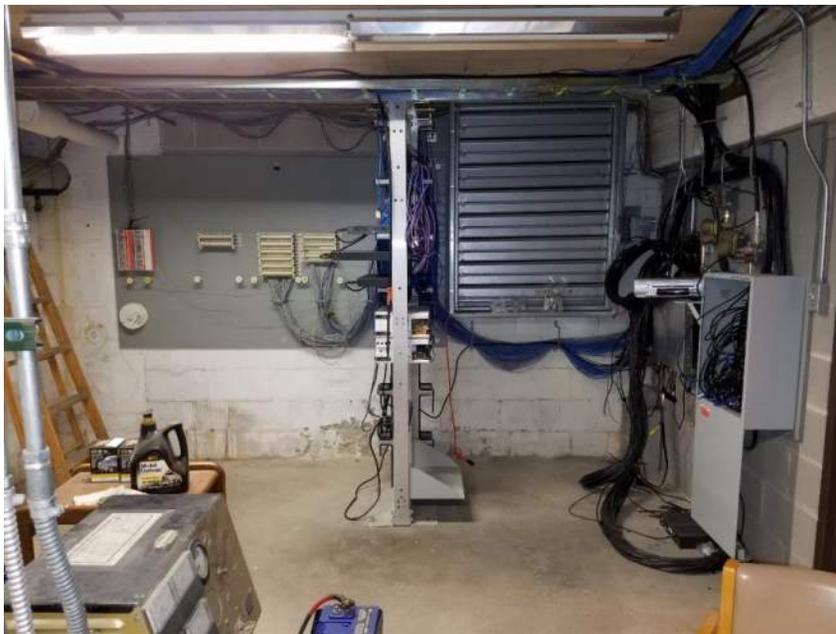
D6010 Data Comm Systems

- Existing Owner furnished equipment includes Wireless Access Points (WAPs) located in various rooms and spaces throughout the building and server/local area network (LAN) gear located in the telecom room.
- The LAN equipment is located in an unconditioned area in the lowest area of the building, it is located in shared space with electrical equipment (and a generator) and is not protected from dust, or other elements. The location of the equipment and the unconditioned space will contribute to the premature failure and demise of Owner's electronic network equipment.
- Existing pathways consist of exposed, surface mounted, 4" conduits for major cable distribution routes, chases to resident rooms and surface raceway for routing voice/data and/or coaxial cables to final location(s).
-

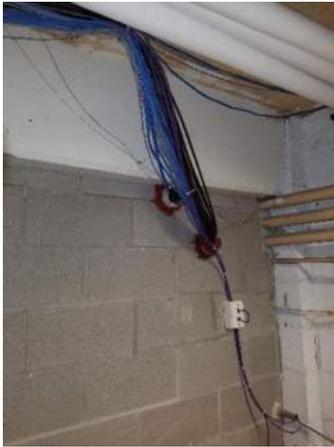
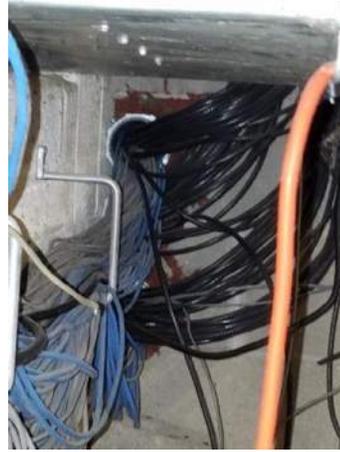
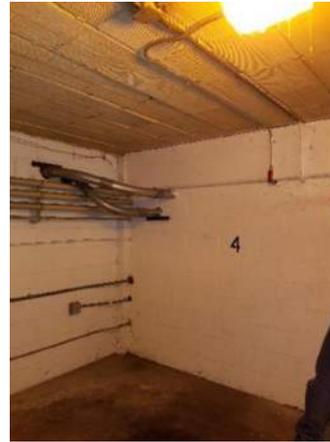
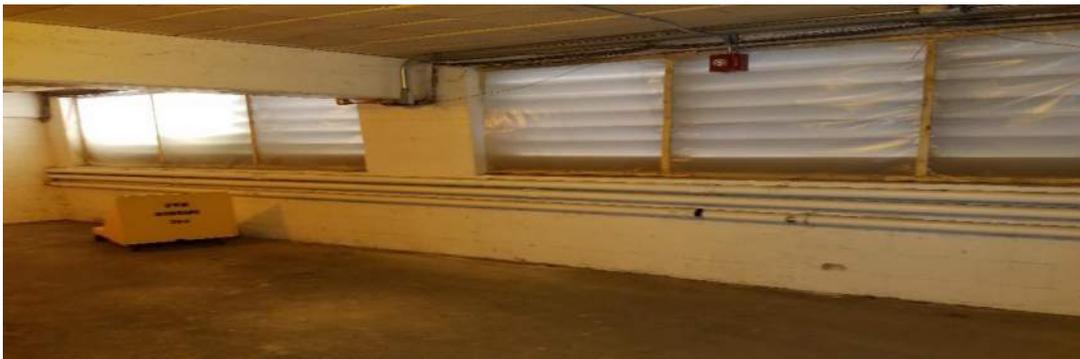
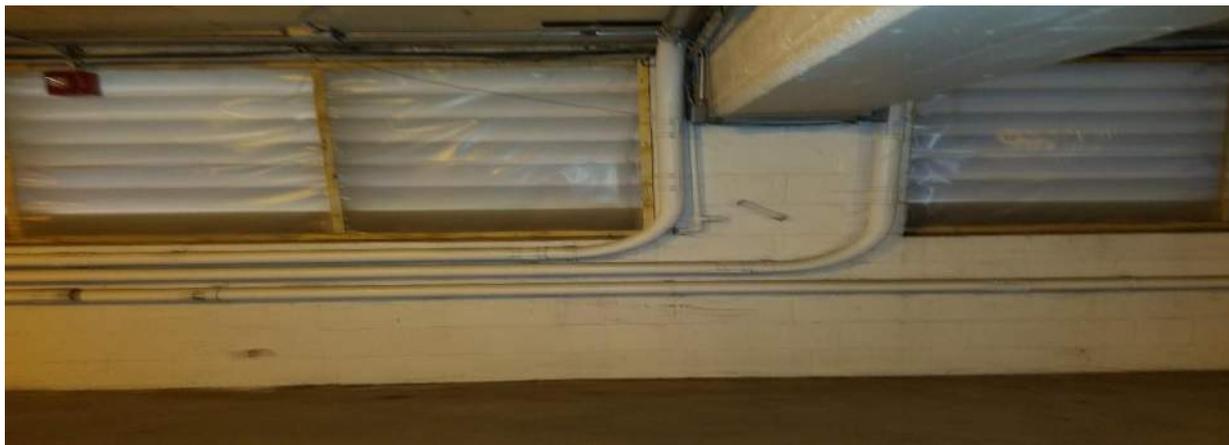
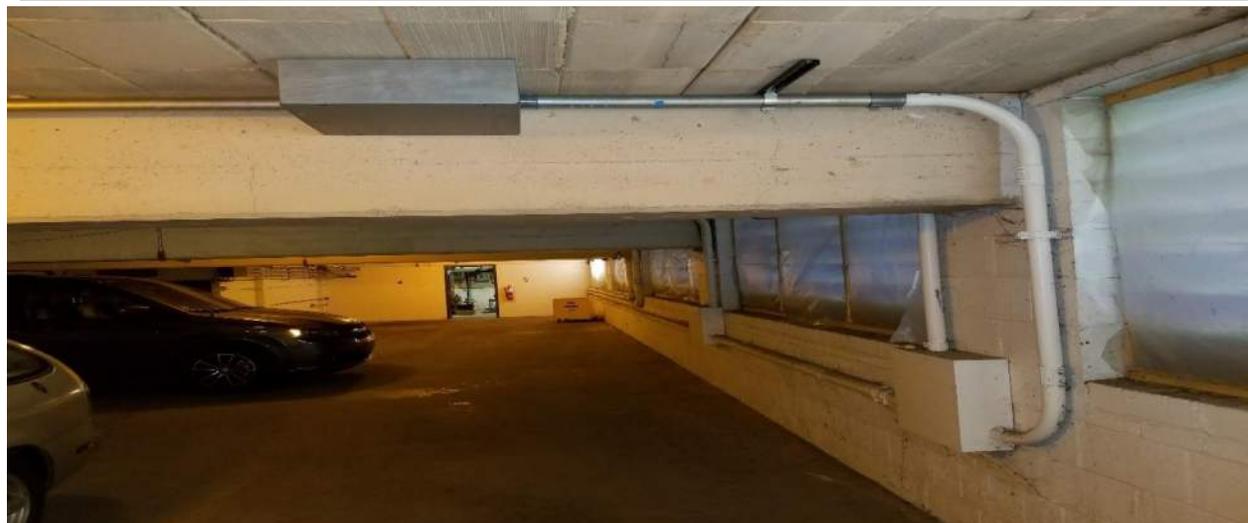
D6020 Telecom Room

- Location of telecom room undesirable, shares space with electrical equipment (including backup generator) and is exposed to dust and temperature extremes due to unconditioned space. Room also shows signs of water erosion on walls. Not recommended for support of new/upgraded technology equipment head end equipment.

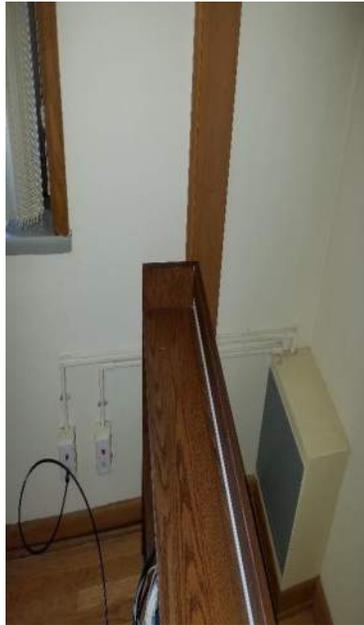
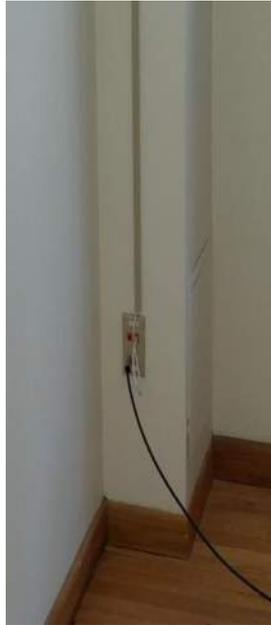
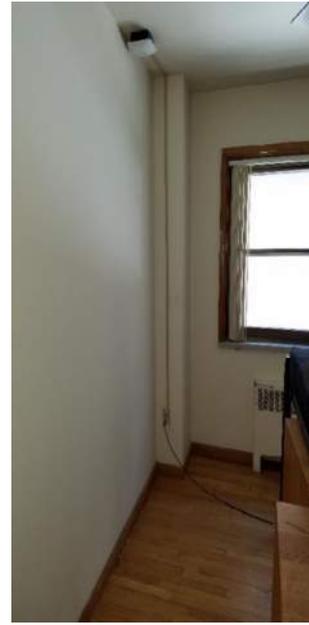
D6030 Voice/Data Cabling Infrastructure

- 90 - 95% of existing cabling infrastructure consists of category 5 cable. Existing cabling should be replaced with Category 6 cabling at hard wired data outlets and Category 6A cabling for Wireless Access Points (WAPs).
- Category 6 cable is recommended for hard wired network connections.
- Category 6A cable is recommended for WAPs.
- Existing, incoming fiber optic cable not capable of supporting current bandwidth demands, or data rates. Cable will become obsolete with the evolution of 40G protocols and data rates.
- Existing, incoming, voice grade copper backbone cable is intact. However, most (if not all) voice cables connected to incoming service have been disconnected and removed from the cabling infrastructure, with exception to the emergency phone in the elevator and the emergency phone at the main entrance.

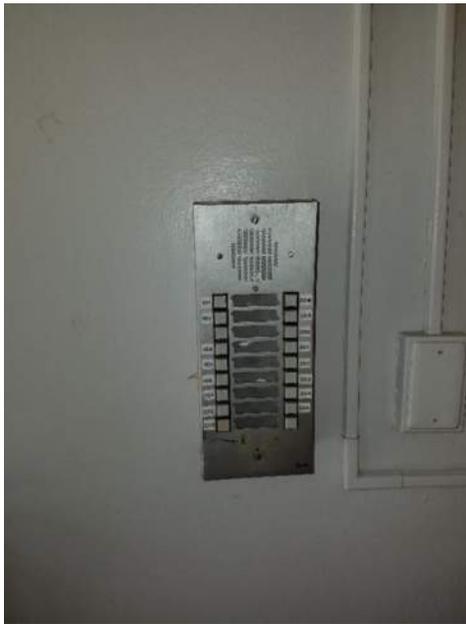
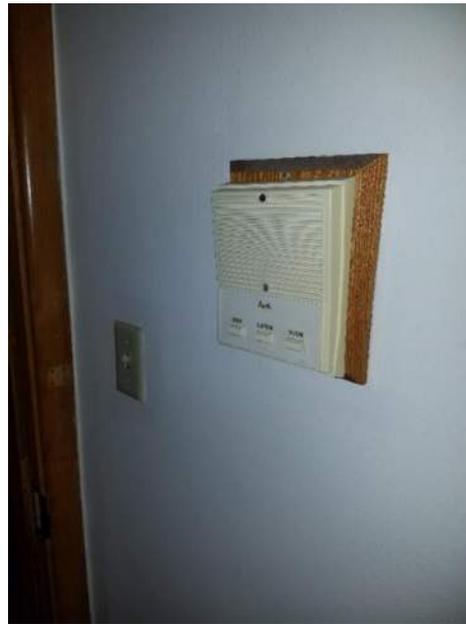
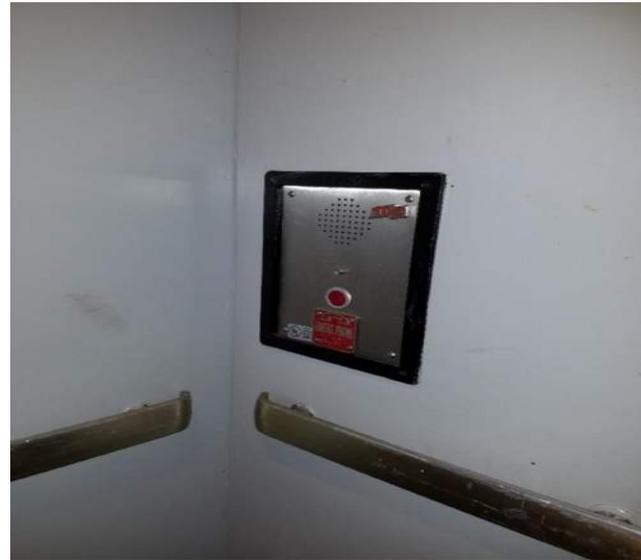
D6040 Voice Communications Systems

- Tenant visitor entry system includes master panel at main lobby and an individual intercom to each resident room for guest entry access. The system appears to be original to the building and does not work. Recommend replacement of intercom system.
- Emergency Phones (1) at Main Entrance and (1) in Elevator. Phones appear to be original to building, or are of considerable age and possibly nearing end of life. Replace.

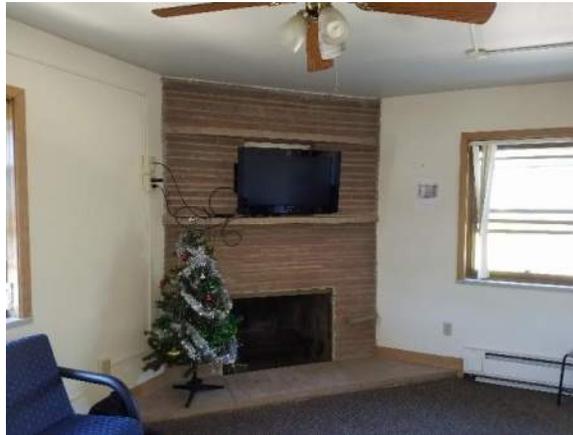
D6050 A/V Systems

- TV in Common Area Lounge. No other AV or entertainment equipment found.

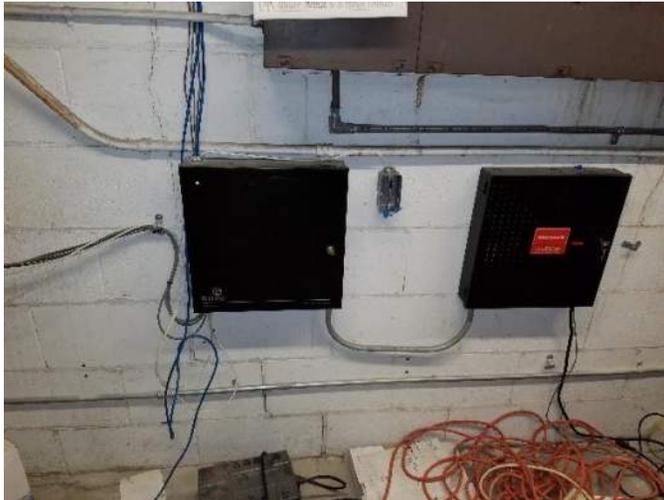
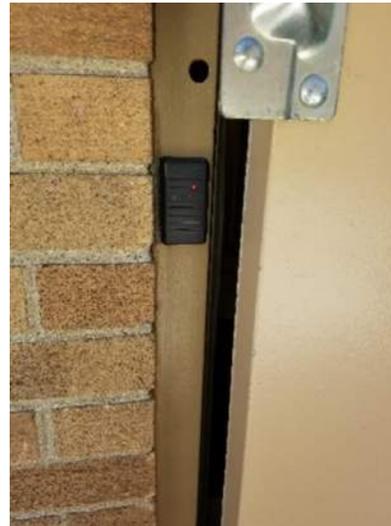
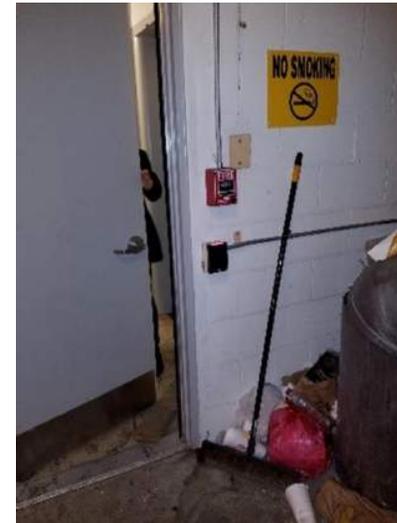
D7010 Access Control & Intrusion Detection Systems

- Existing system is an Access Control System only. No intrusion detection component(s) found.
- System includes credential readers (CR) at each exterior entry door to the building and a CR at the interior garage entry door leading into the common corridor of the residence space.

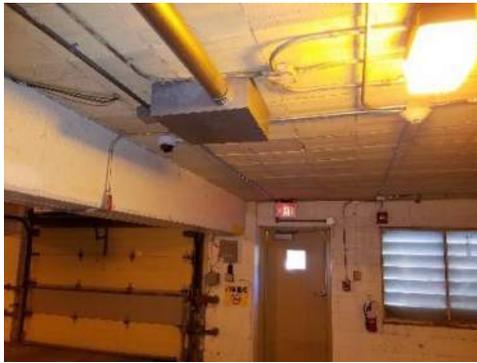
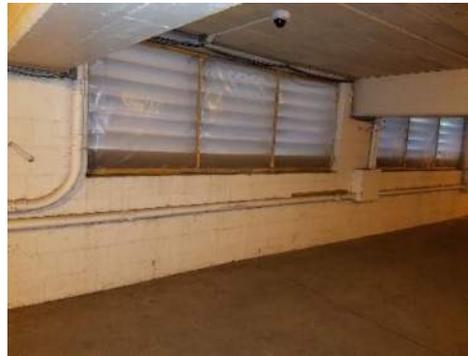
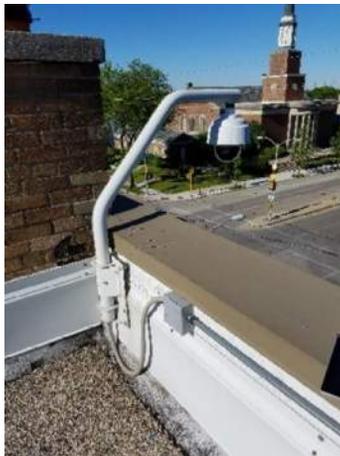
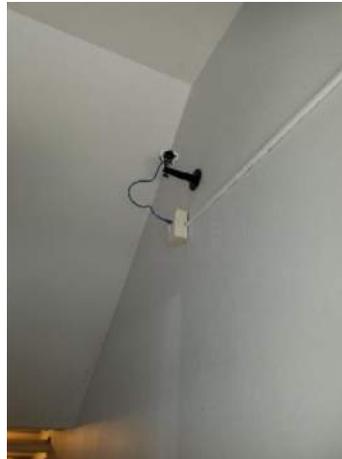
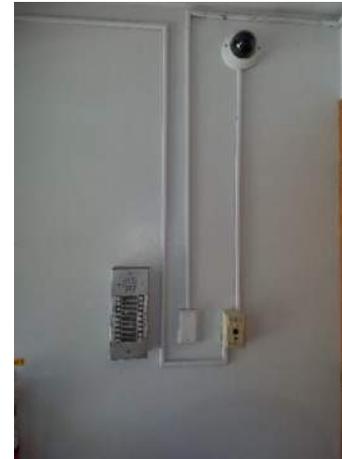
D7030 Electronic Surveillance

- Building has (5) IP surveillance cameras (approximately 5 years of age or older). Cameras monitored off-site by UWM PD. Could not assess camera functionality or resolution due to off-site monitoring station. Cameras appear to be in fair condition and functioning.

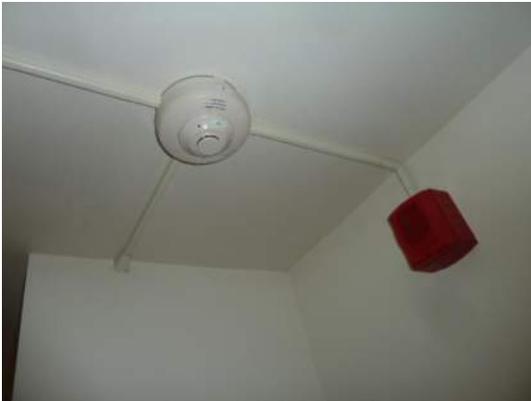
D7050.10 Fire Alarm

- A Notifier addressable fire alarm panel with voice notification is located in the main vestibule.
- Smoke detectors are located in most common/public spaces of the building.
- Smoke alarms are also provided in resident units.
- Notification devices are provided throughout the building.
- Pull stations are located at exits.
- The fire alarm system was replaced and updated in a 2012 project. All equipment.
- Smoke detection and fire alarm interface for elevator recall and shutdown is not present per current code.
- No fire alarm devices are present in the attic space.
